PRELIMINARY NONDESTRUCTIVE EVALUATION MANUAL FOR THE SPACE SHUTTLE

**PRELIMINARY NONDESTRUCTIVE EVALUATION MANUAL
FOR THE SPACE SHUTTLE**

APPENDIX TO FINAL REPORT

**LOCKHEED-GEORGIA COMPANY
A DIVISION OF LOCKHEED AIRCRAFT CORPORATION
MARIETTA, GEORGIA 30063**

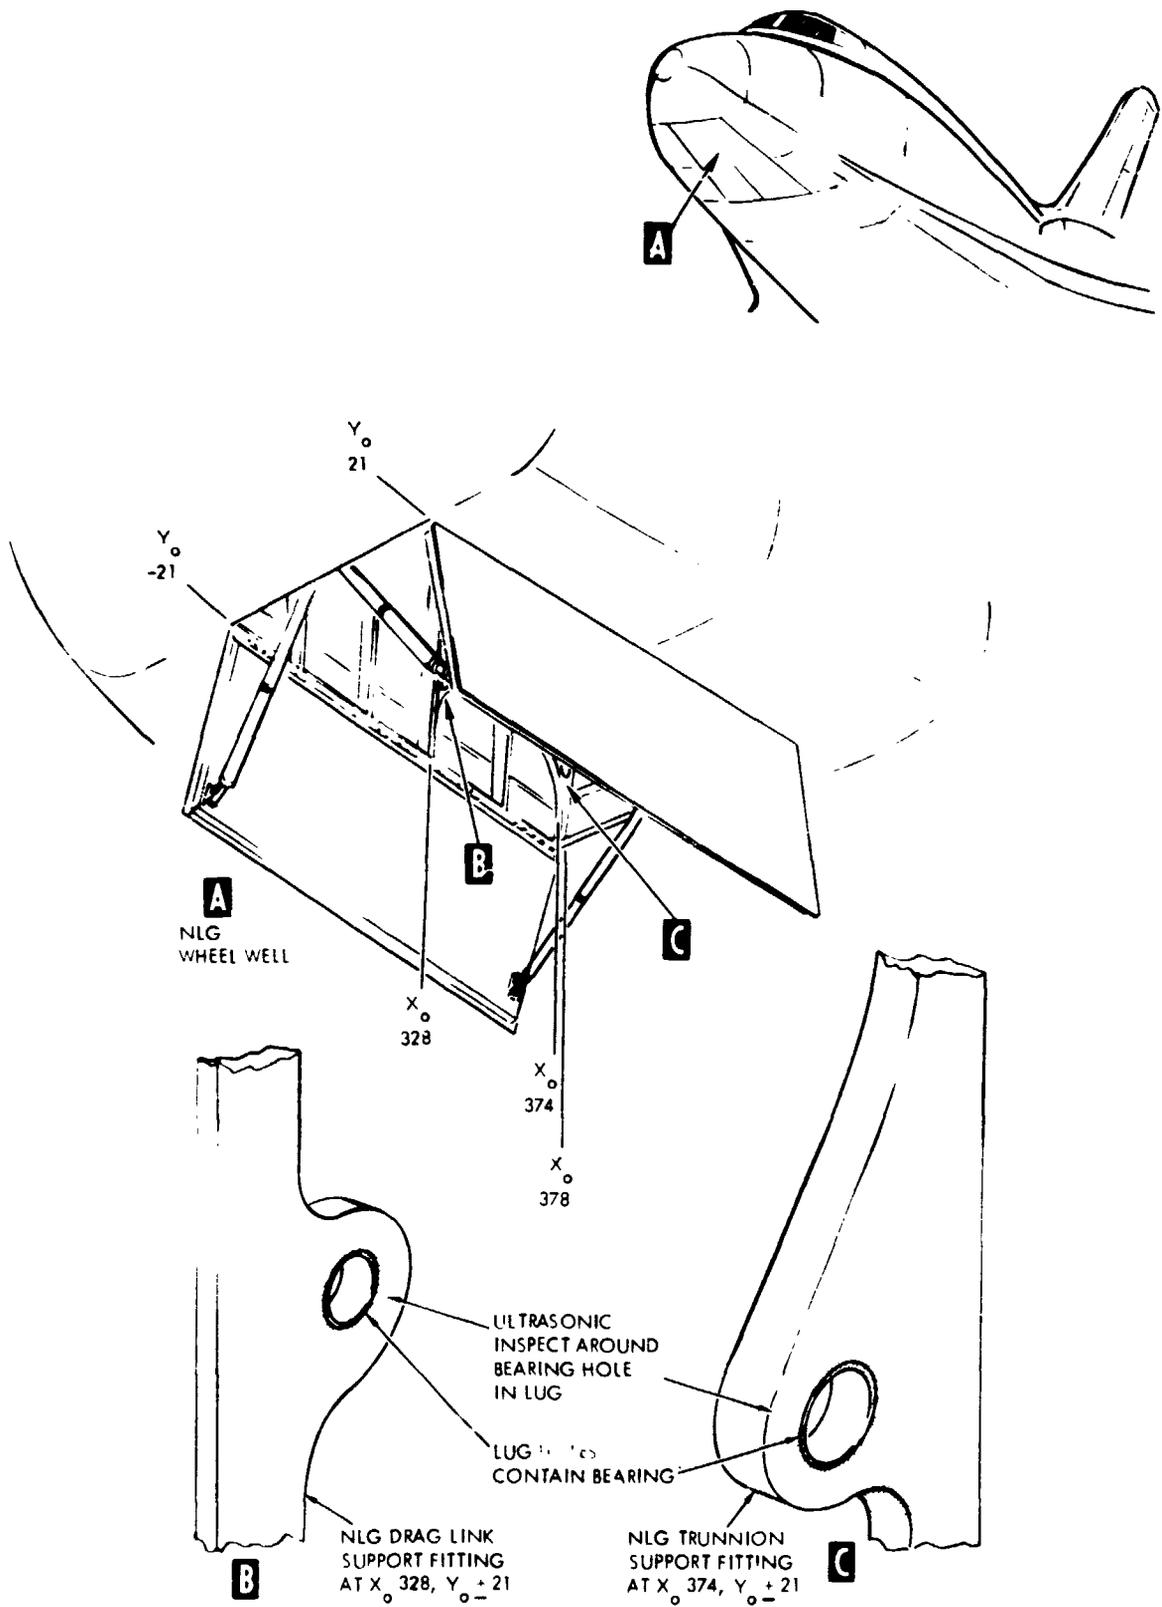
Figure 2-5. NLG Drag Link Support and Trunnion Support Fittings

NDT TECHNIQUE: Primary: Ultrasonic shear wave or eddy current (see paragraphs 1.5.5.3 B or C and 1.5.4.4, respectively).

Backup: Fluorescent penetrant (see paragraph 1.5.2.1, Figure 1-9).

PROCEDURE NO. 2-201, Figure 2-5

PROCEDURE NO. 2-202, Figure 2-5

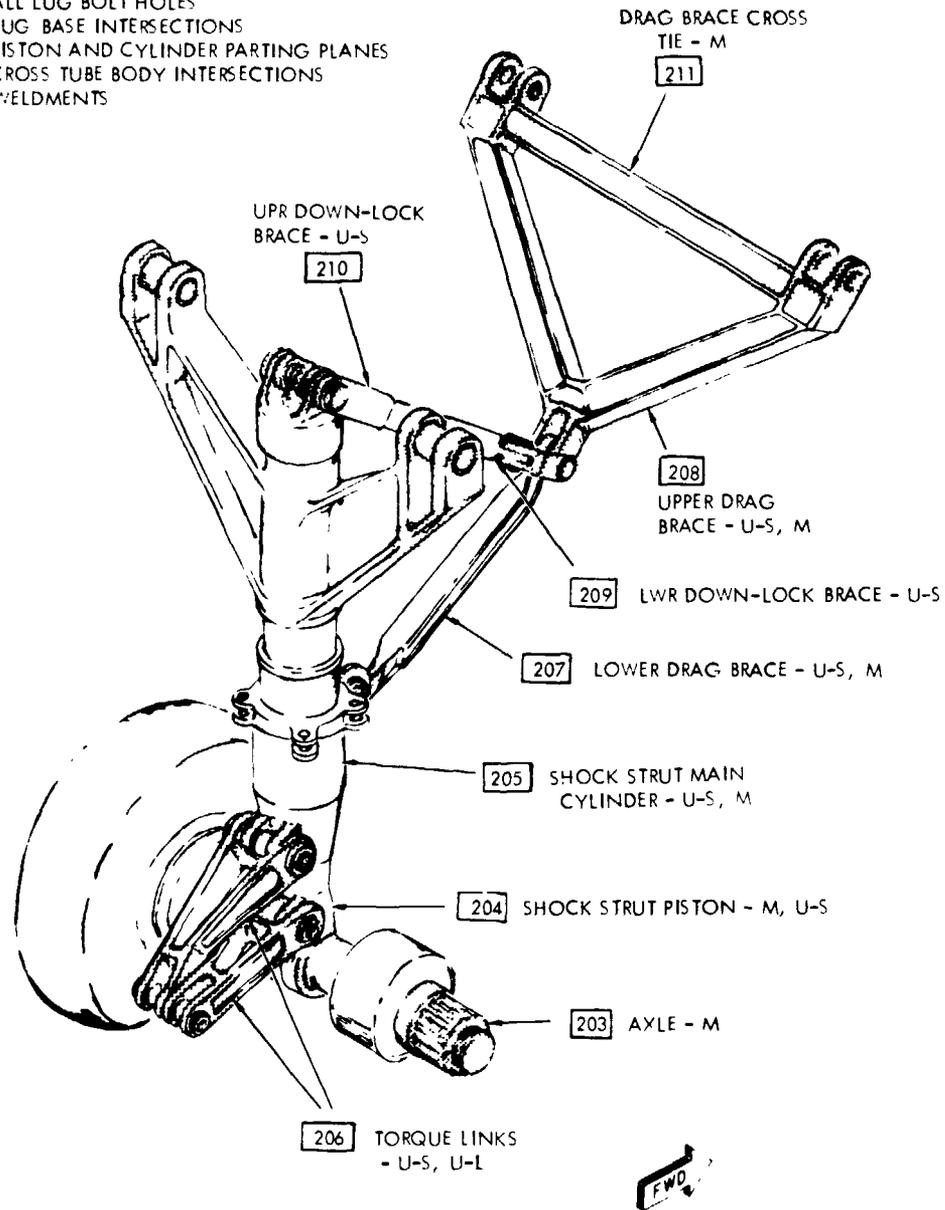
Figure 2-6. Nose Landing Gear Assembly

U-L -- ULTRASONIC LONGITUDINAL WAVE INSPECTION

INSPECT: ALL LUG BOLT HOLES
LUG BASE INTERSECTIONS
PISTON AND CYLINDER PARTING PLANES
CROSS TUBE BODY INTERSECTIONS
WELDMENTS

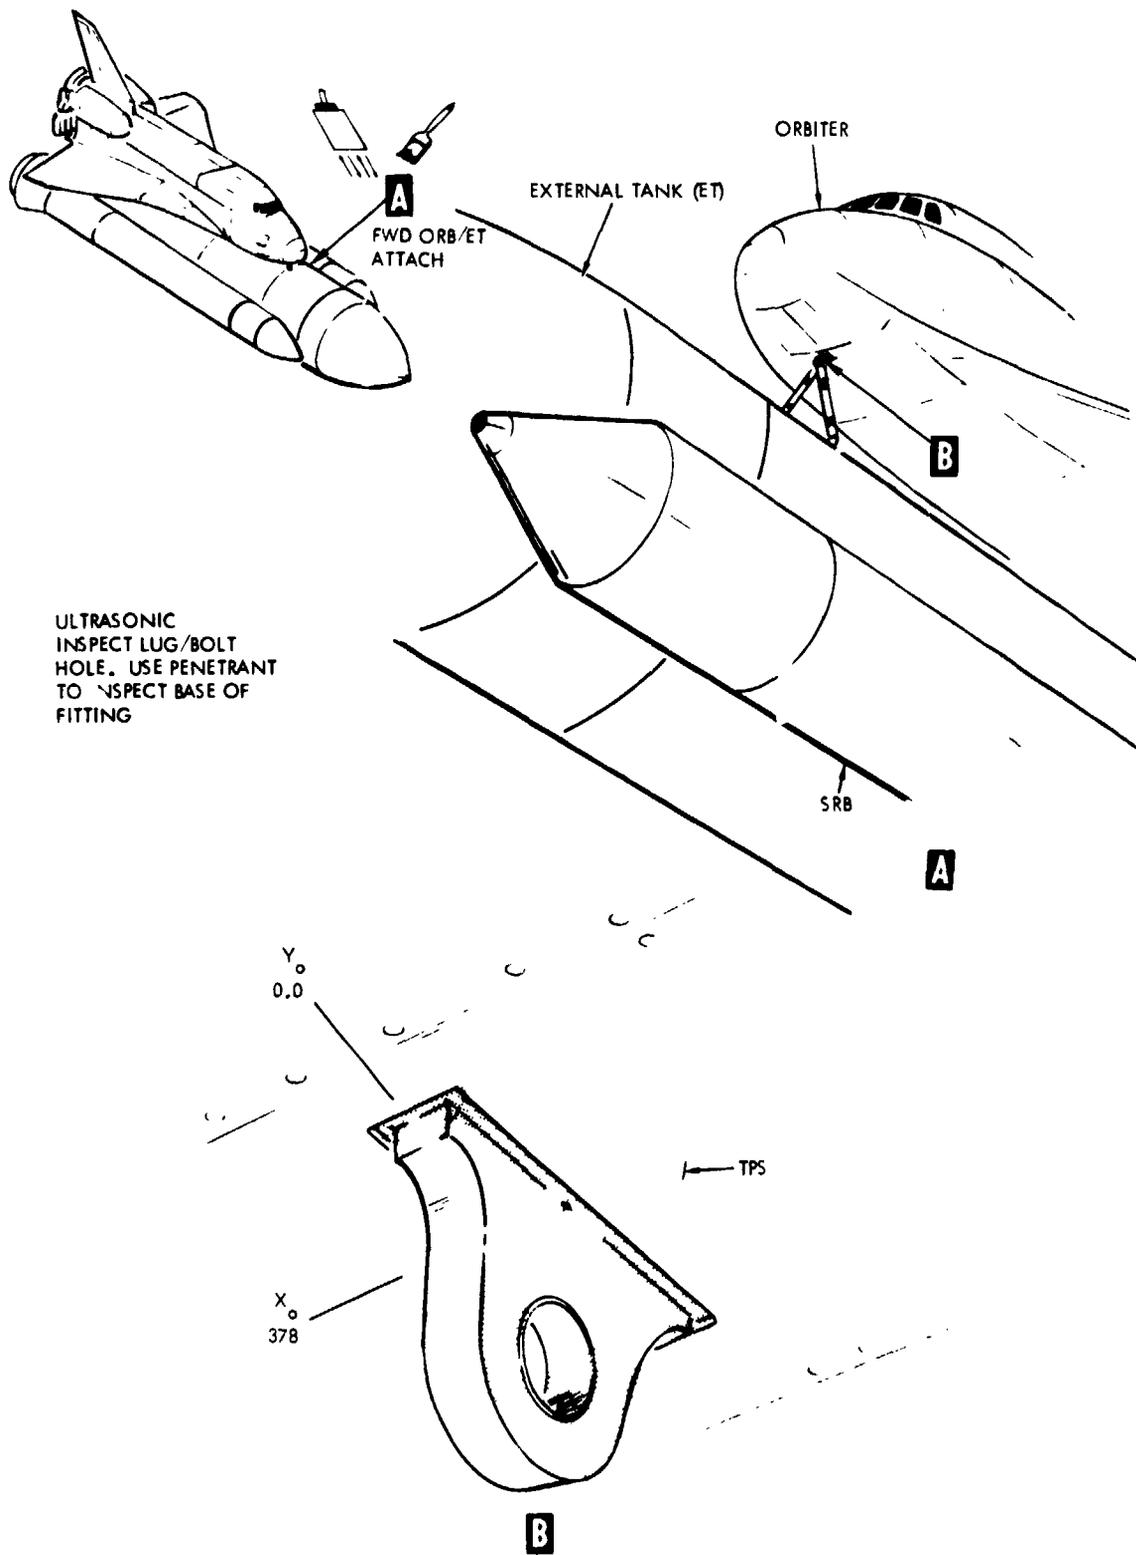
Figure 2-7. Forward ET/Orbiter Attach Fitting

ACCESS: Access is readily attained by removing local TPS materials.

NDT TECHNIQUES: Primary: Ultrasonic (see para 1.5.5.3 B), fluorescent penetrant (see para. 1.5.2.1 Figure 1-9).

PROCEDURE NO. 2-212, Figure 2-7

PROCEDURE NO: 8-907, FIGURE 2-7

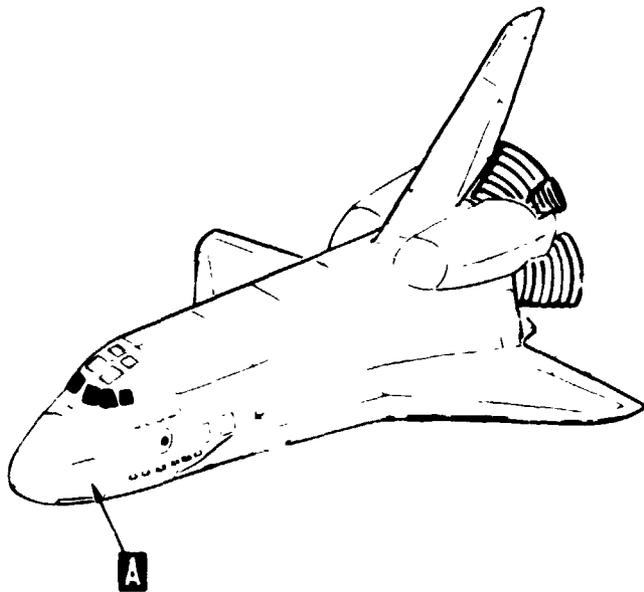
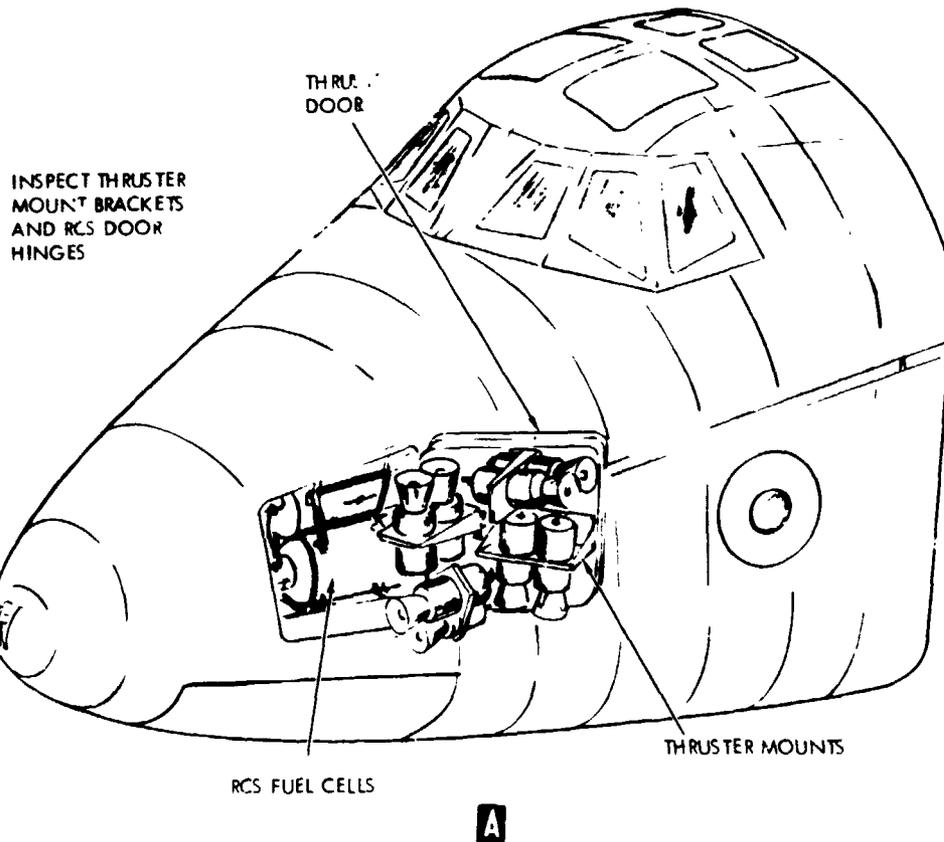
Figure 2-8. Forward RCS Module Structural Attachment Areas

ACCESS: Open RCS thruster deployment doors on each side of forward fuselage nose section.

NDT TECHNIQUES: Primary: Eddy current (see paragraph 1.5.4.4)
Backup: Fluorescent penetrant (see paragraph 1.5.2.1
Fig. 1-9).

INSPECT THRUSTER
MOUNT BRACKETS
AND RCS DOOR
HINGES

THRU.
DOOR

PROCEDURE NO. 2-213, Figure 2-8

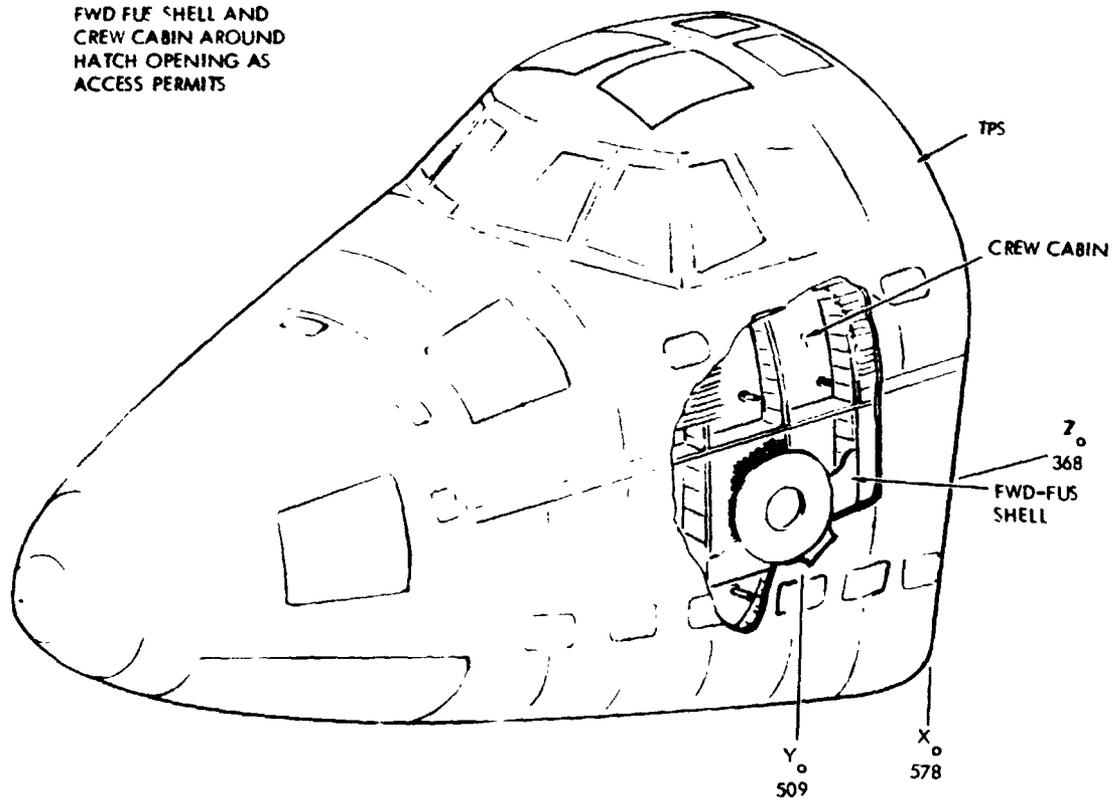
Figure 2-9. Crew Module Entrance Hatch

INSPECT HINGE, FRAME,
AND SKIN STRUCTURE IN
FWD FUS SHELL AND
CREW CABIN AROUND
HATCH OPENING AS
ACCESS PERMITS

FWD FUS CREW CABIN -
CREW INGRESS EGRESS HATCH

PROCEDURE NO. 2-214, Figure 2-9

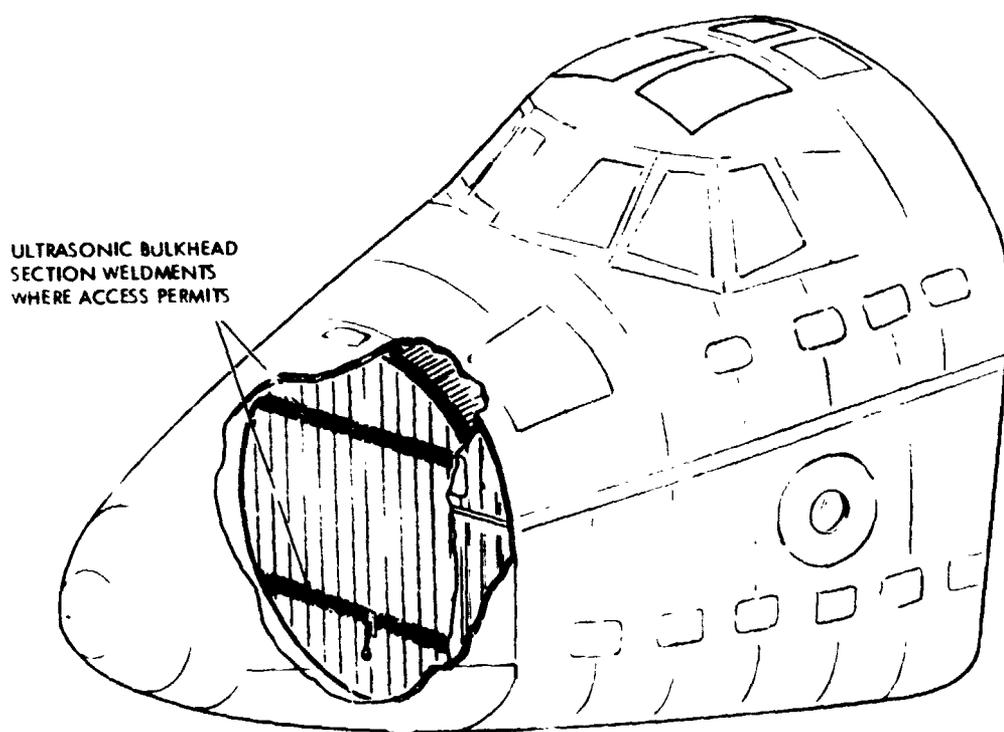
Figure 2-10. Cabin Forward Bulkhead

NDT TECHNIQUES: Primary: Ultrasonic shear and/or surface wave (see para. 1.5.5.3 C or 1.5.5.1) or fluorescent penetrant (see para. 1.5.2.1 Fig. 1-9).

Backup: Eddy current (see para. 1.5.4.4) or fluorescent penetrant (see para. 1.5.2.1, Fig. 1-9)

CREW CABIN FORWARD BULKHEAD AT X 384

PROCEDURE NO. 2-301, Figure 2-10

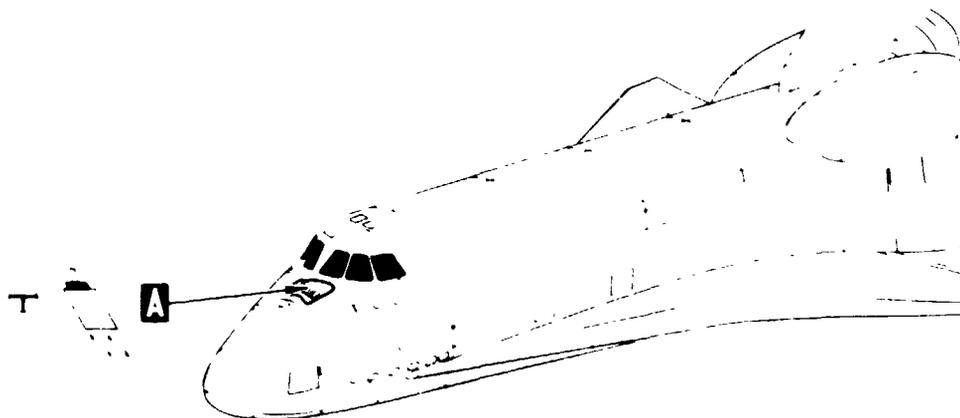
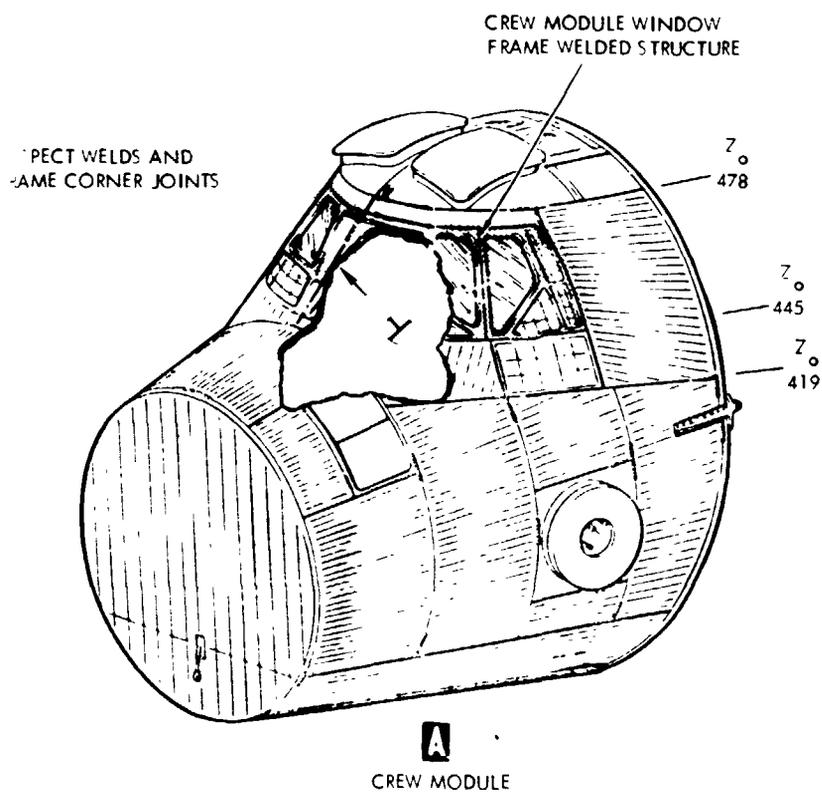
Figure 2-11. Crew Cabin Window Frames

NDT TECHNIQUES: Primary: X-ray Radiography (see para. 1.5.6.2) and ultrasonic shear wave (see para 1.5.5.3 C)

Backup: Penetrant (see para. 1.5.2.1, Fig. 1-9)

PROCEDURE NO. 2-302, Figure 2-11

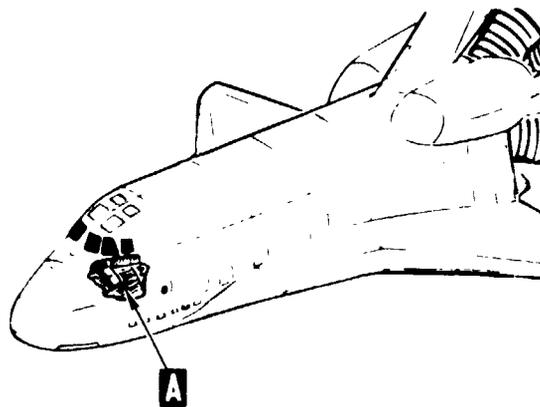
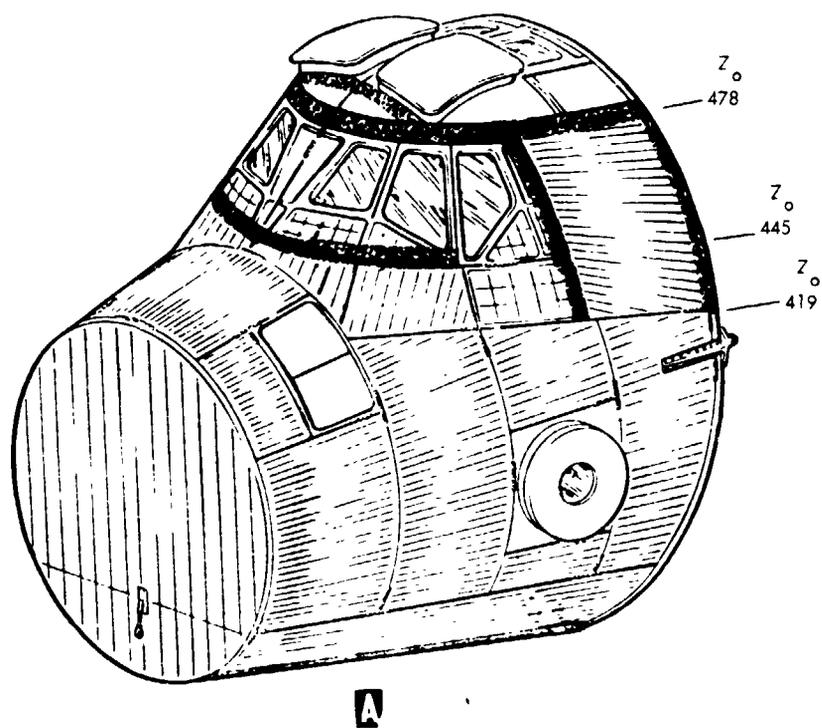
Figure 2-12. Cabin Canopy Panels

NDT TECHNIQUES: Primary: Ultrasonic shear and/or surface wave (see para. 1.5.5.3 C or 1.5.5.1) or x-ray radiography (see para. 1.5.6.2) for welds.
Backup: Fluorescent penetrant (see para. 1.5.2.1, Fig 1).

ULTRASONIC OR
 RADIOGRAPHIC (DEPENDENT ON
 INSPECT WELDS ACCESS)
 AROUND CANOPY
 JOINTS

CREW CABIN CANOPY PANELS

PROCEDURE NO. 2-303, Figure 2-12

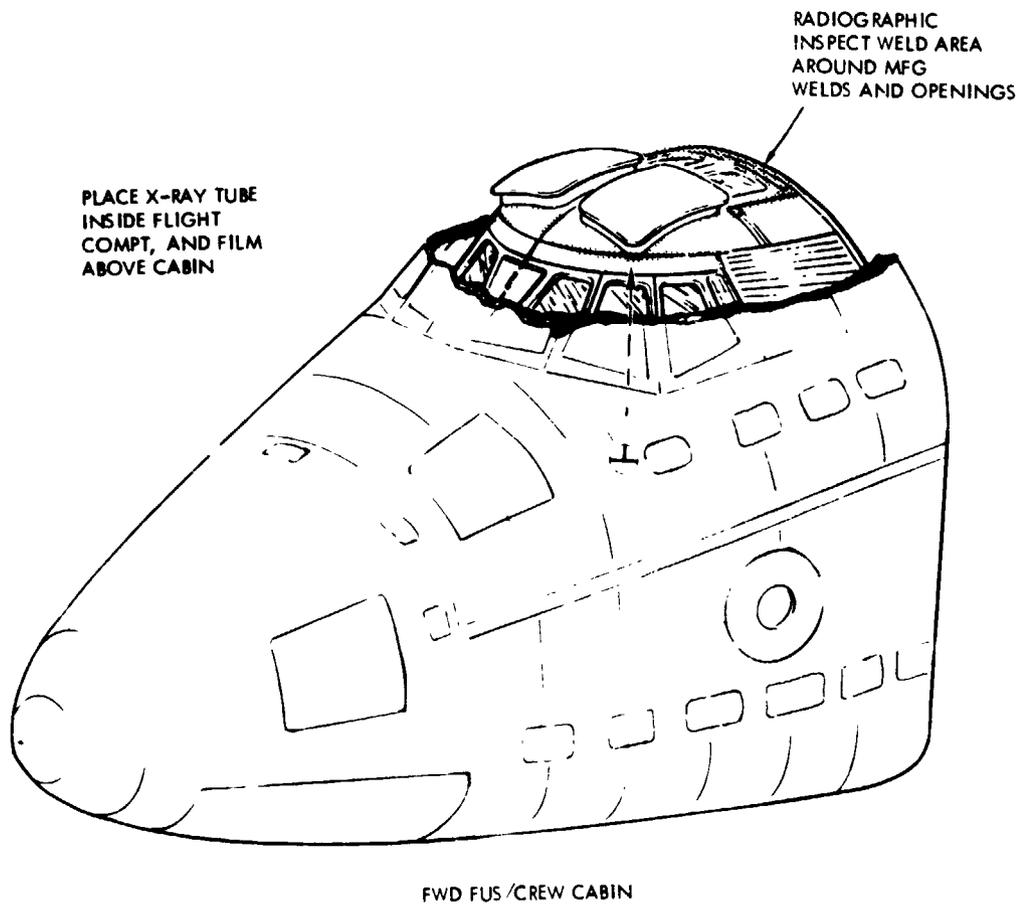
Figure 2-13. Cabin Manufacturing Access Panels

ACCESS: From inside upper crew cabin and from outside top of forward fuselage. For backup, removals of hatch door, interior insulation and equipment may be necessary.

NDT TECHNIQUES: Primary: X-ray radiography (see para. 1.5.6.2).
Backup: Eddy current and/or shear wave, depending on area access (see para. 1.5.4.4 or para. 1.5.5.3 C)

PROCEDURE NO. 2-304, Figure 2-13

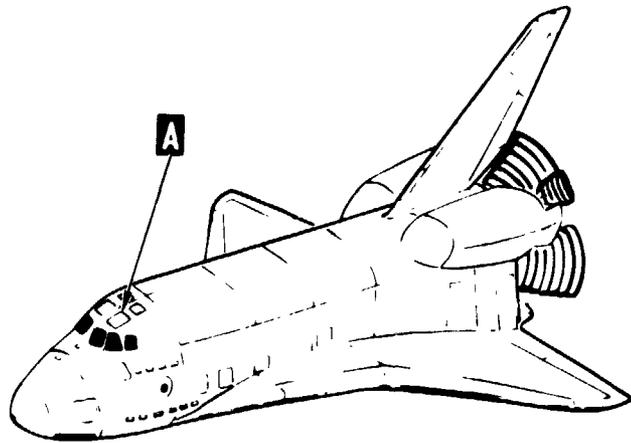
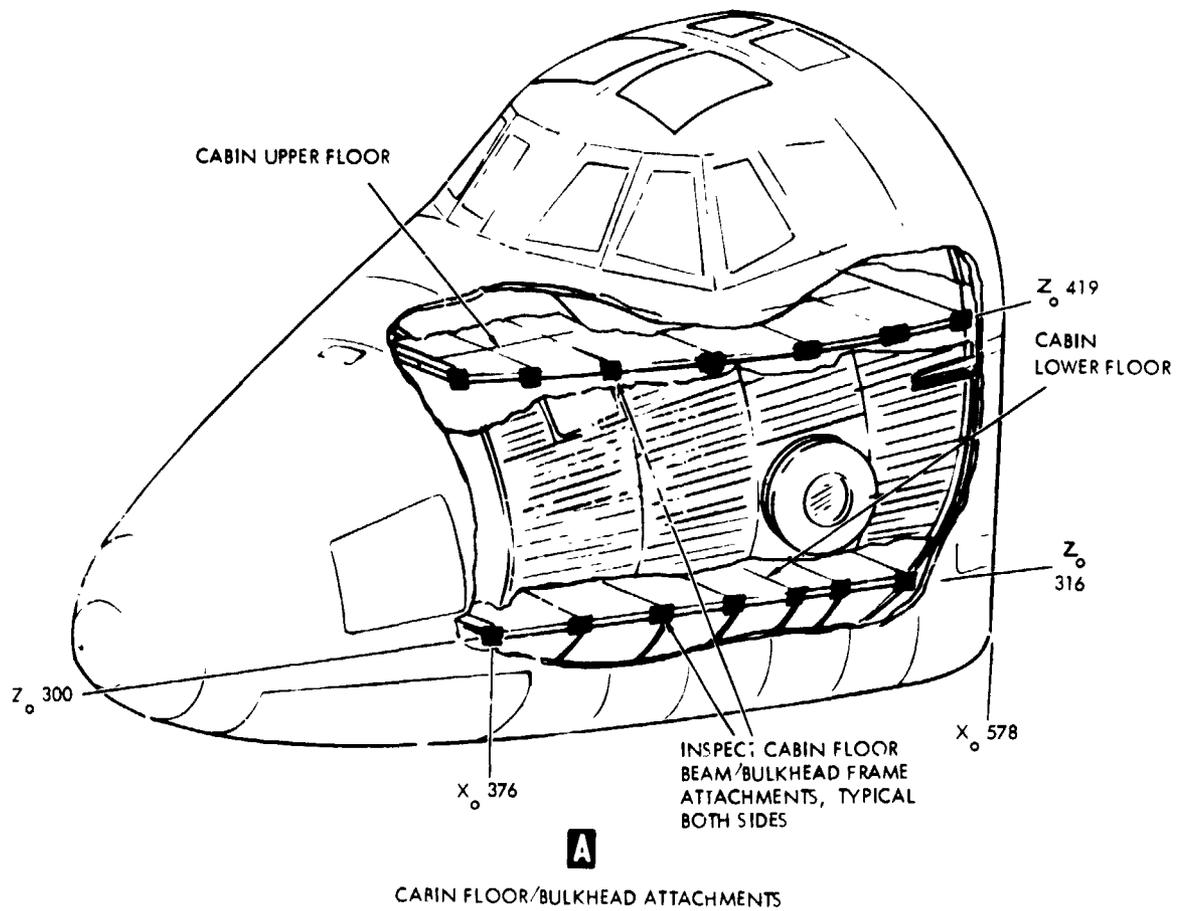
Figure 2-14. Cabin Floor/Bulkhead Beams

NDT TECHNIQUES: Applicable Methods: Eddy current surface probe (see para. 1.5.4.4) ultrasonic shear wave (see para. 1.5.5.3 C) and radiography (para. 1.5.6.2)

NOTE: Better definition of beam structure design and access are needed for assignment of NDT technique.

PROCEDURE NO. 2-305, Figure 2-14

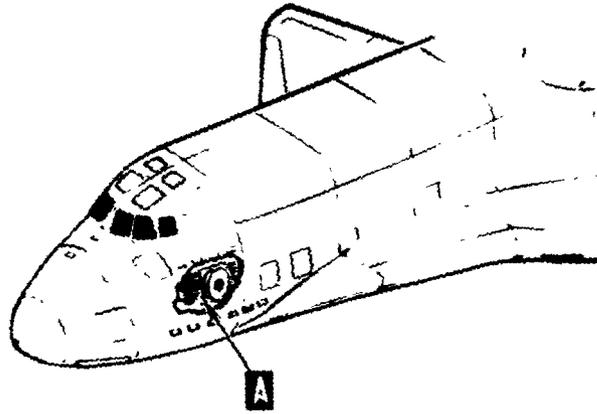
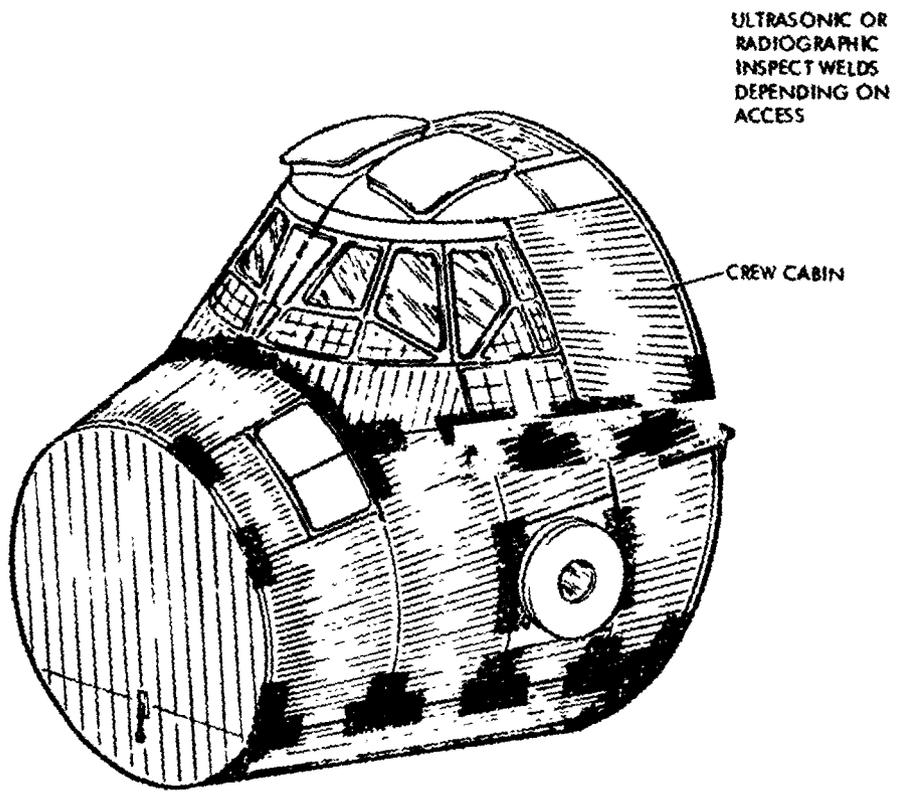
Figure 2-15. Cabin Skin Panels

ACCESS: From inside the cabin upper and lower compartments. Removal of equipment and TCS materials will be required (not defined).

NDT TECHNIQUES: Primary: Ultrasonic shear and/or surface wave (see para. 1.5.5.3 C or 1.5.5.1) for welds where access permits. Optical, eddy current and x-ray may be applied to other areas where access requirements dictate.

A
CREW CABIN SKIN
PANEL WELDMENTS

PROCEDURE NO. 2-306, Figure 2-15

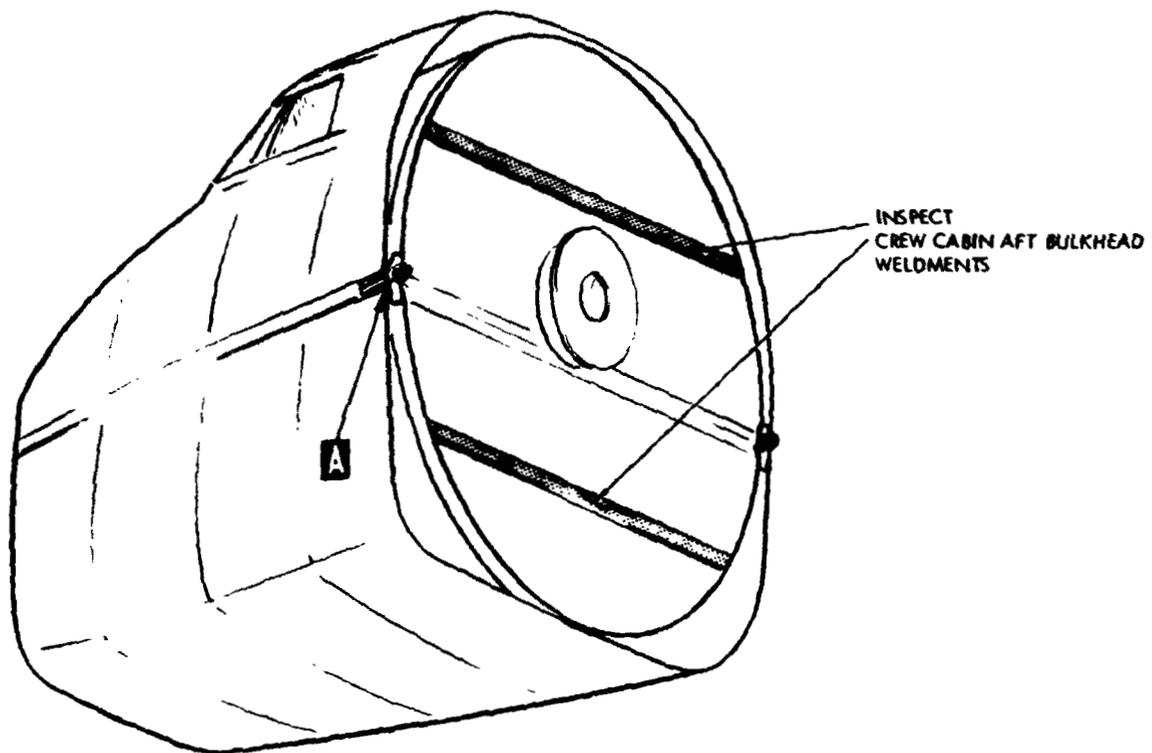
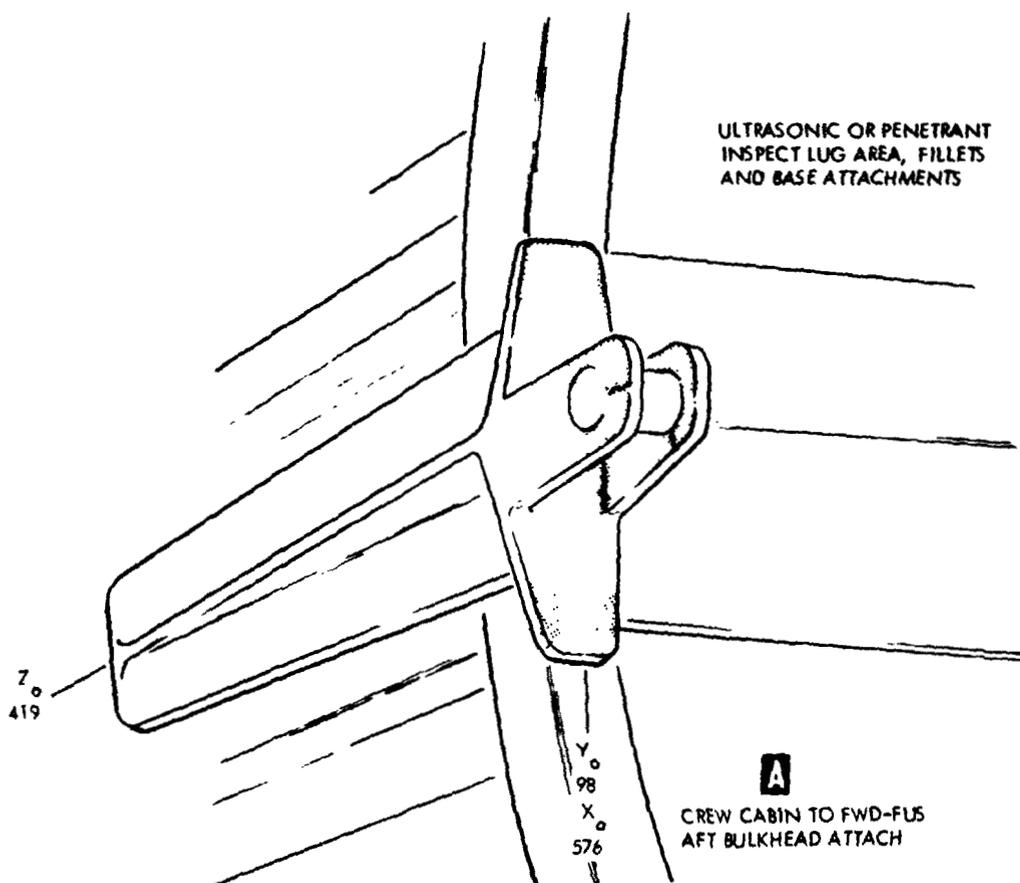
Figure 2-16. Cabin Aft Bulkhead

NDT TECHNIQUES: Primary: Ultrasonic shear and/or surface waves (see para. 1.5.5.3 C or 1.5.5.1) for welds. Ultrasonic or eddy current for other areas.

PROCEDURE NO. 2-307, Figure 2-16

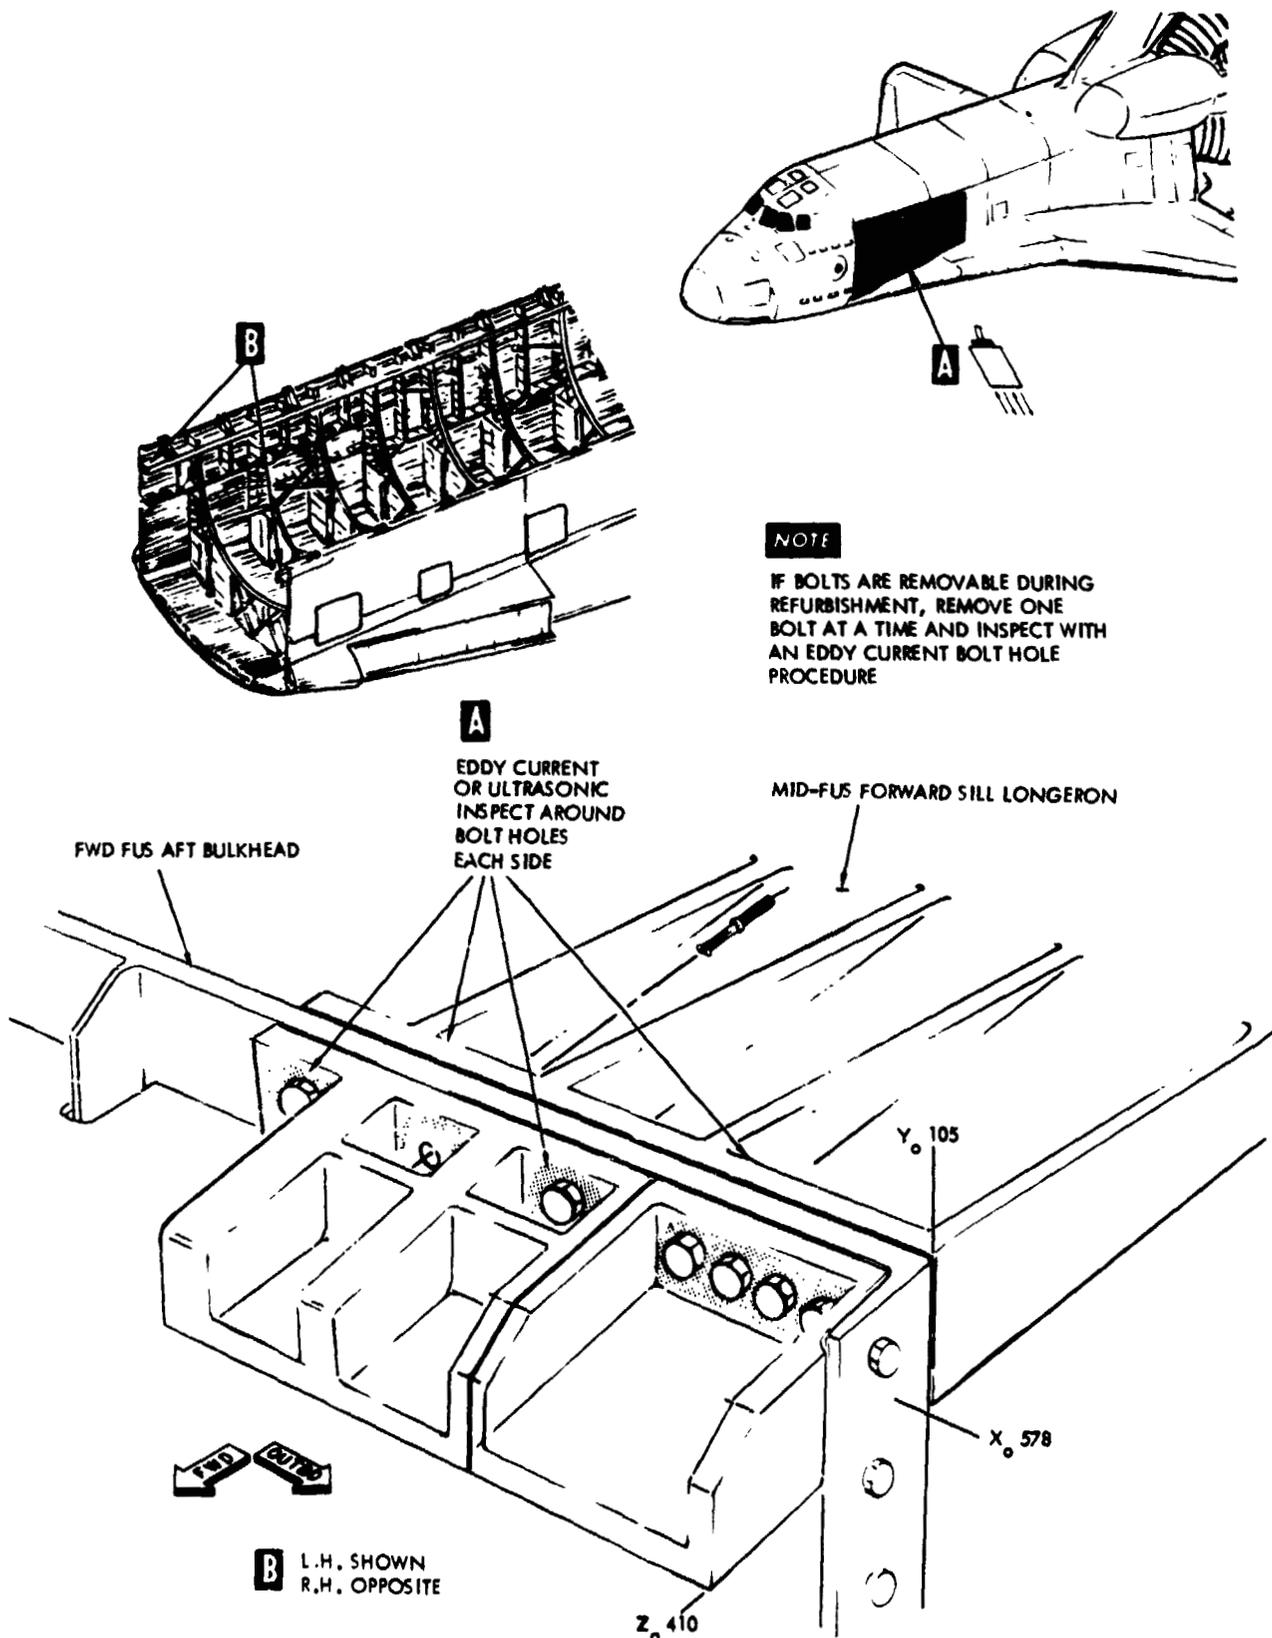
Figure 3-1. Payload Bay Forward Sill Longeron

NDT TECHNIQUES: Primary: Eddy current bolt hole at butt splice (see para. 1.5.4.3); ultrasonic and eddy current at frame attachment area (see para 1.5.5.3 C or para. 1.5.4.4).

Backup: Fluorescent penetrant (see para 1.5.2.1 Fig. 1-9).

PROCEDURE NO. 3-401, Figure 3-1

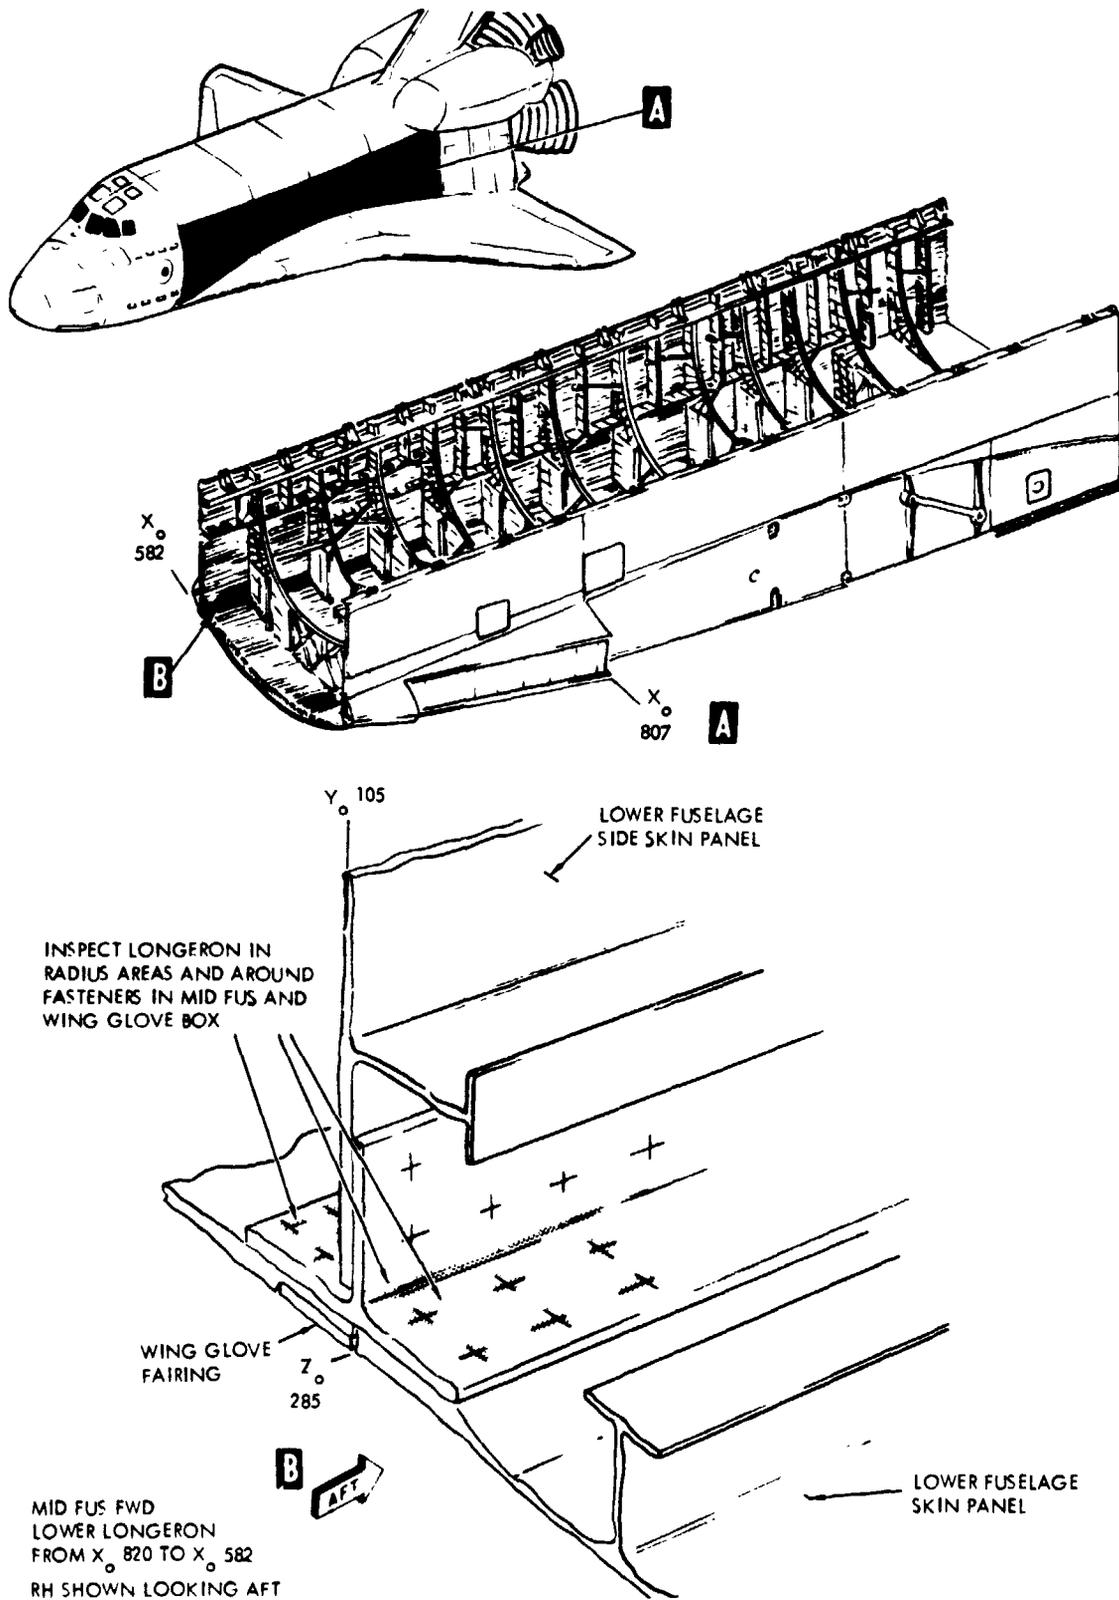
Figure 3-2. Payload Bay Lower Forward Longeron

NDT TECHNIQUES: Primary: Eddy current (para 1.5.4.4) and ultrasonic shear wave (para. 1.5.5.3 C).

Backup: Fluorescent penetrant (para. 1.5.2.1 Fig 1-9) for cracks in flange. Eddy current bolt hole (para 1.5.4.3) for cracks at attach fasteners (fastener removed).

PROCEDURE NO. 3-402, Figure 3-2

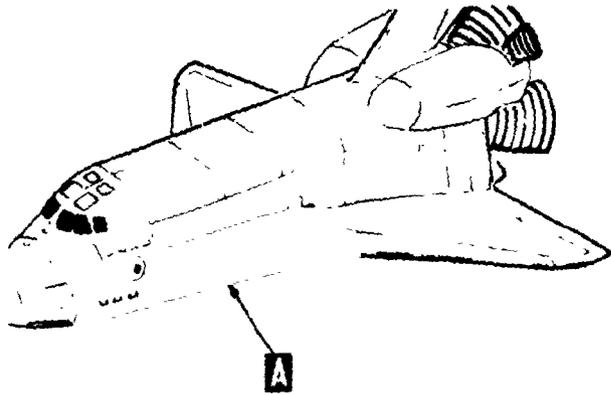
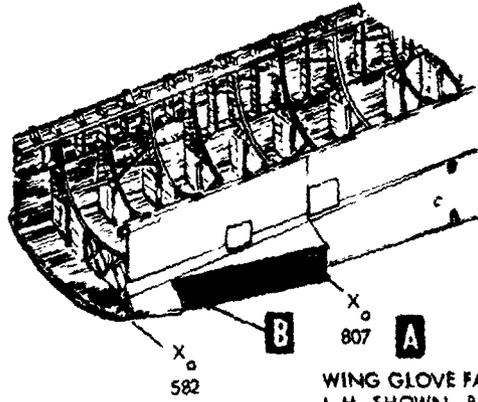
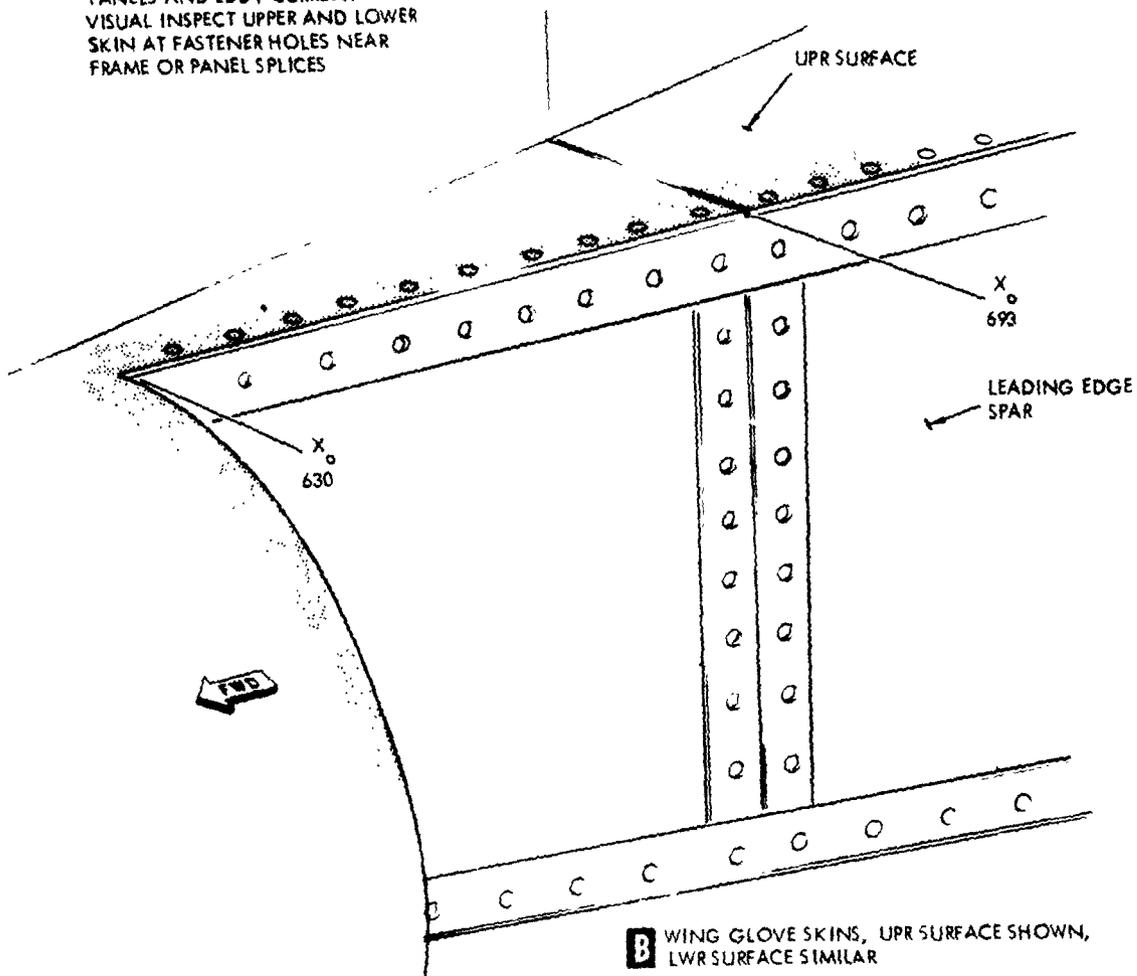
Figure 3-3. Glove Fairing Skins

ACCESS: Remove leading edge access panels top and bottom from X_o 626 to X_o 800.

NDT TECHNIQUES: Primary: Eddy Current (para. 1.5.4.4) and visual
Backup: Penetrant (para. 1.5.2.1 Fig. 1-9)

WING GLOVE FAIRING
L.H. SHOWN, R.H.
OPPOSITE

REMOVE LEADING EDGE ACCESS
PANELS AND EDDY CURRENT/
VISUAL INSPECT UPPER AND LOWER
SKIN AT FASTENER HOLES NEAR
FRAME OR PANEL SPLICES

B WING GLOVE SKINS, UPR SURFACE SHOWN,
LWR SURFACE SIMILAR

PROCEDURE NO. 3-403, Figure 3-3

PROCEDURE NO. 3-409 , Figure 3-3

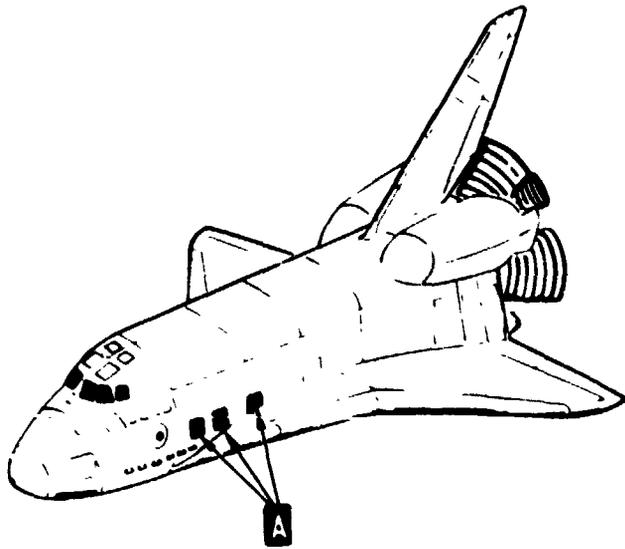
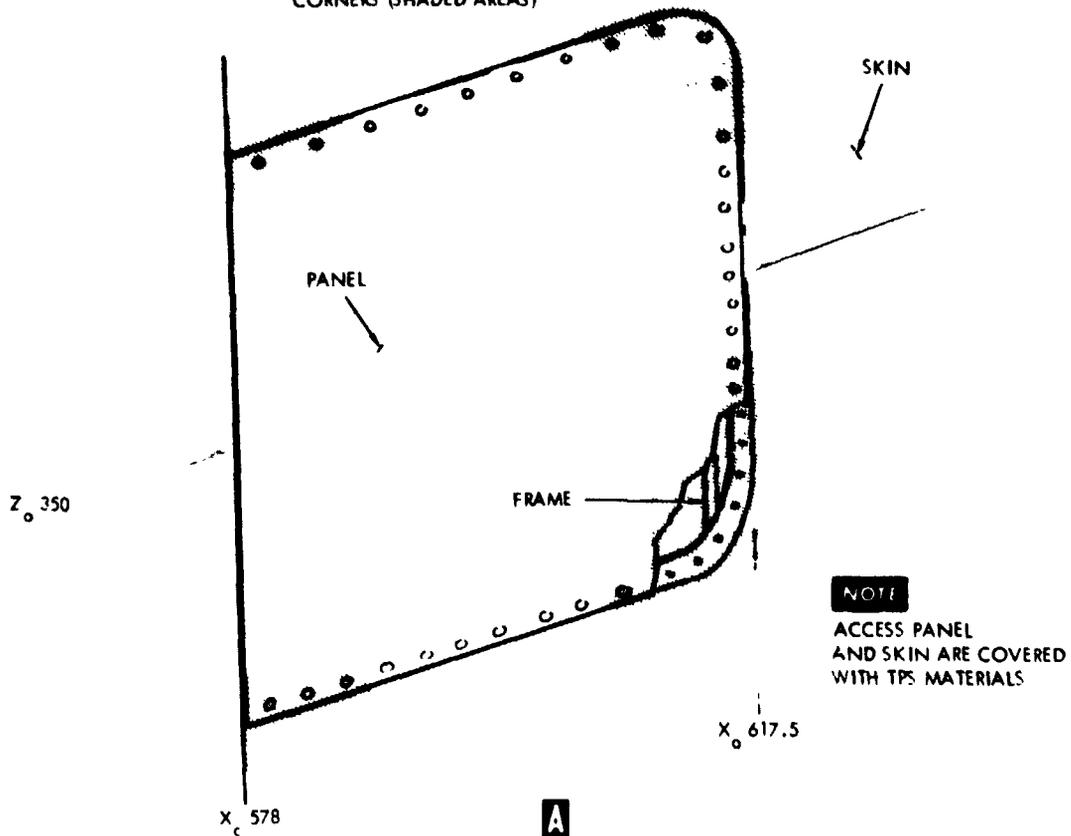
Figure 3-4. Mid-Fuselage Access Openings

There are three rectangular access openings on each side of the mid-fuselage which provide personnel access for maintenance and servicing of systems ECLSS and others. They are: (1) the mid-fuselage maintenance and ECLSS servicing access openings centered at Z_o 350, X_o 599 (LH), X_o 617 (RH), X_o 651 (LH) and X_o 672 (RH); Z_o 356, X_o 824. Because these openings are penetrations into primary load carrying structure, stress concentrations at the corners of these openings may cause fatigue damage in these areas. The structure is composed of 2024 aluminum alloy, finished with zinc chromate primer and Supercorapon 515-700 paint, and covered externally by LHRI/TPS panels.

DEFECTS: Cracks may occur at the (upper and lower, forward and aft) corners of the structure forming the frame of the openings, originating at fastener holes or in the interior corner edges. The cracks should be inspected on the interior and exterior surfaces of the frame structure.

NDT TECHNIQUES: Primary: Eddy current (see para. 1.5.4.4)
Backup: Fluorescent penetrant (para. 1.5.2.1 Fig. 1-9)

INSPECT INTERIOR STRUCTURE
AND SKIN AT ACCESS OPENING
CORNERS (SHADED AREAS)

TYPICAL MID-FUS EQUIPMENT
ACCESS PANEL, THREE EACH
SIDE UP FUSELAGE
